Berko Electric - MBB-M Baseboard Heater Repair Program - How To Check Your Heater

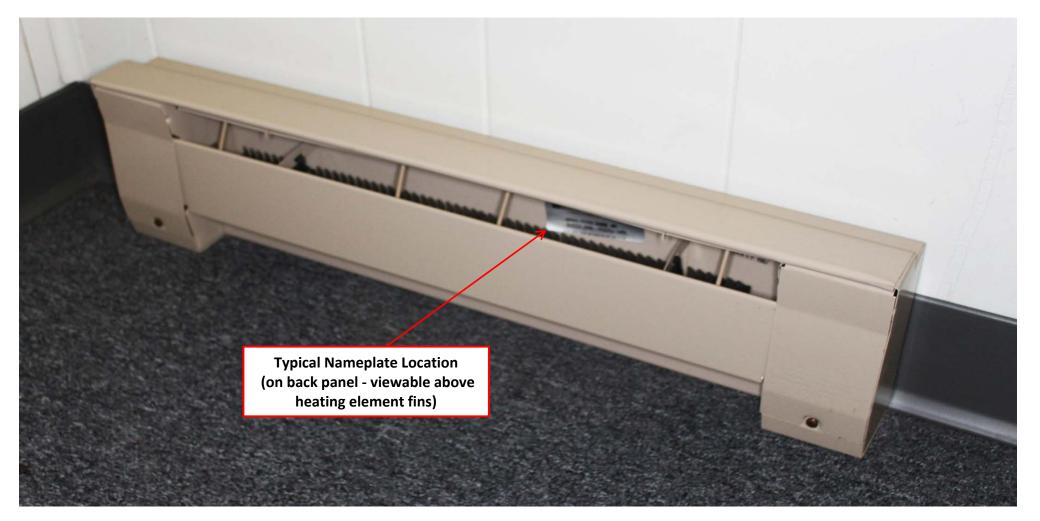
Overal View of Heater (2 ft. unit shown for clarity)

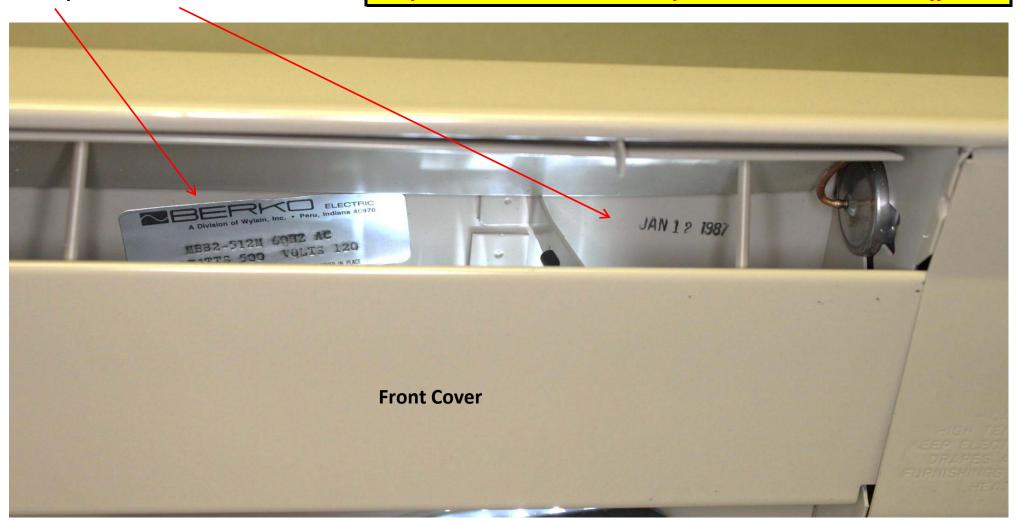
Nameplate and Date Code Locations

Only Date Codes Between January 1980 and March 1987 are Affected

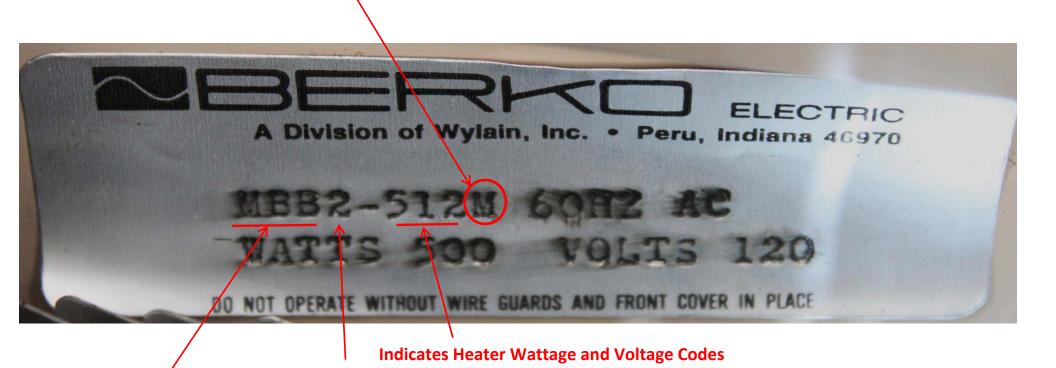
Nameplate Photo (Model MBB2-512M Shown for Clarity)

IMPORTANT NOTE: ONLY Models with Suffix "M"are included in this Field Repair Program

Indicates MBB Series

Indicates Heater Length in Feet

NOTE: If your heater is an MBB - M model, go to next page for additional instructions.

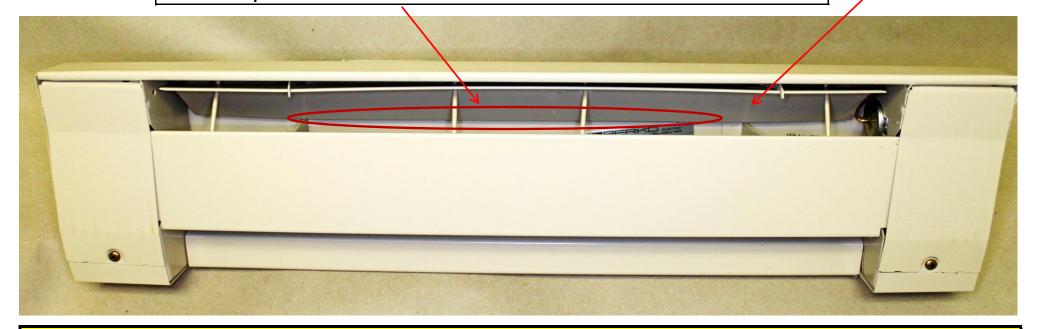
How to Inspect Your Heater for Possible Damage:

Air Deflector

Look for paint discoloration in this area of the air deflector at bottom near back

Action Required For Affected MBB-M Heaters

- If you find the paint to be discolored, disconnect power to the heater until it can be repaired or replaced.
- If you <u>do not</u> find the paint discolored, the heater should be repaired or replaced as soon as possible, but may continue to be used.
